**A RESERVE STUDY FOR**

**ABC Condominium  
Appletown, FL  
File # 22920-01234**

**FOR PERIOD: January 1, 2010 – December 31, 2010**

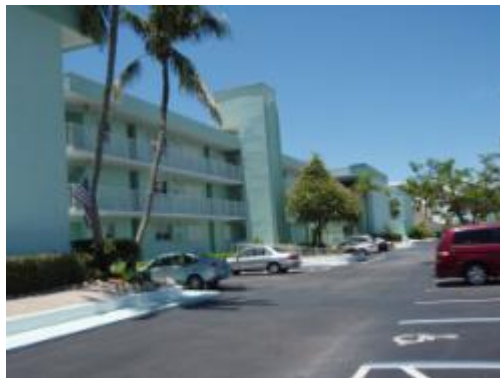
Asphalt Overlay - A properly designed, installed and maintained asphalt pavement should require an asphalt overlay on an 18-20 year basis. No professional pavement assessments were provided that would suggest that physical conditions exist that would limit the useful life of the asphalt paving. The paved areas are based on a site/irrigation plan provided by the association, which was assumed to be complete and correct. The current costs include minor structural repairs to the underlying road subbase and curbing/drainage, installation of a typical asphalt overlay, restriping and curb stops replacement.

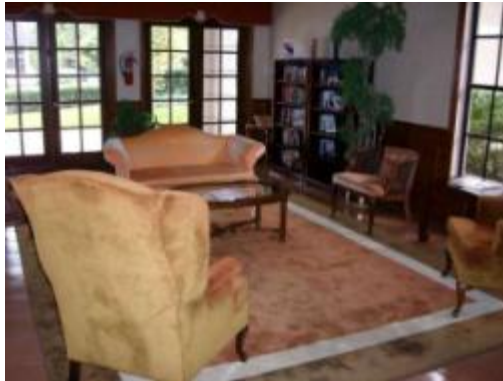
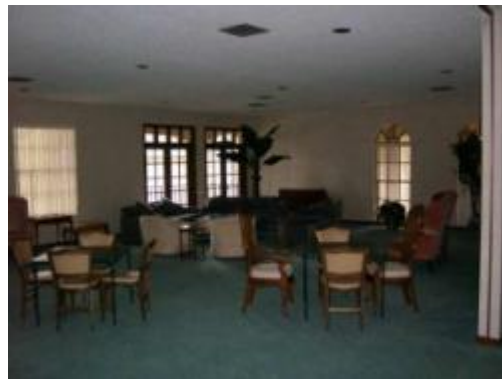
Furniture/Furnishings, Clubhouse – While miscellaneous replacements will be necessary from time to time, the association should expect to incur costs associated with inventory replacement of the furniture/furnishings (tables, chairs, sofas, window treatments, artwork, silk plants, lamps/light fixtures, kitchen appliances, etc.) on a 12-15 year life cycle, while replacement of administrative office furnishings can often last up to 20 years under normal operating conditions. We have therefore forecast inventory replacement of the furniture/furnishings in the multipurpose rooms in 2016 and the office furnishings in 2022. The current costs are based on our experience with furnishings upgrades on an average \$/square foot of building area.

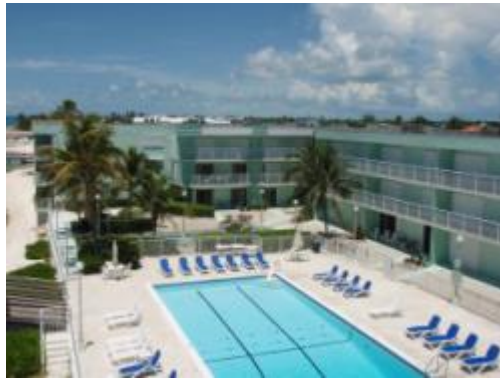
Pool Deck Pavers Repair/Replacement – This fund is designed to provide monies for major restoration and eventual replacement of the brick paver decking at the pool. This upgrade is typically included in reserve budgets on a 20-25 year life cycle; utilizing a 24 year life cycle indicates this expense in 2026. The current cost estimate includes removal and disposal of the existing pavers and installation with like quality, and is reflective of a unit cost of \$5.89/square foot and the total area of +/- 3,700 square feet.

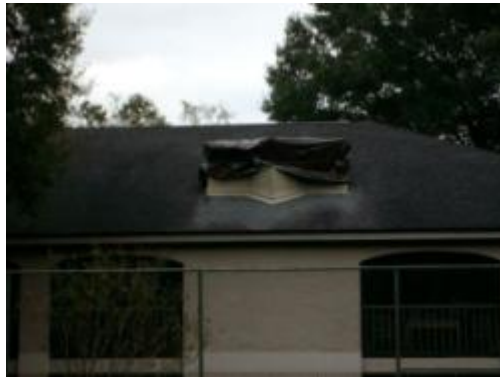
Roof Replacement, Clubhouse – The clubhouse features pitched tile roofing; this type of roofing should enjoy a useful life of up to 30 years under normal operating conditions. Since no professional roofing studies were provided that would indicate physical conditions exist that would limit the useful life of this roofing, this expense has been forecast in 2032, The current cost, which includes expenses associated with tear off and disposal of the existing roofing, typical incidental repairs to the underlying roof structures, flashing, fascia, soffits, etc., is based on market standards that suggest a unit cost in the low to high \$700 per square from range (one square = 100 square feet). The roof has a total area of +/- 95.1 squares. For the purposes of this analysis, a current cost estimate of \$71,800 has been utilized.

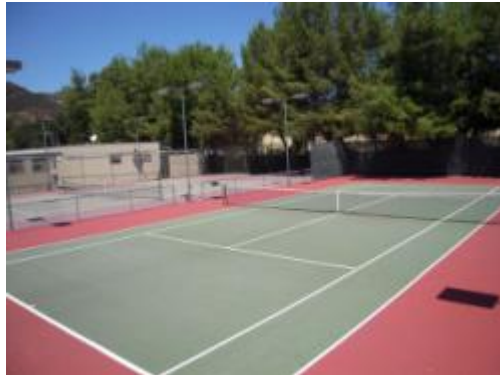
Tennis Court Resurfacing – Tennis court resurfacing in better quality properties like the subject can be expected on a 6-8 year life cycle, to insure proper protection of the underlying court structures and a high cosmetic appeal. Therefore, the association should expect to incur costs associated with this upgrade no later than 2010. The market indicates a per court cost in the mid \$2,000 to low \$3,000 range, often depending on the scope of repairs necessary to the underlying court structures.
